**Flood Control Project Maintenance
Levee Inspections**

Fall 2011 Levee Maintenance Deficiency Summary Report

Lake County Watershed Protection District

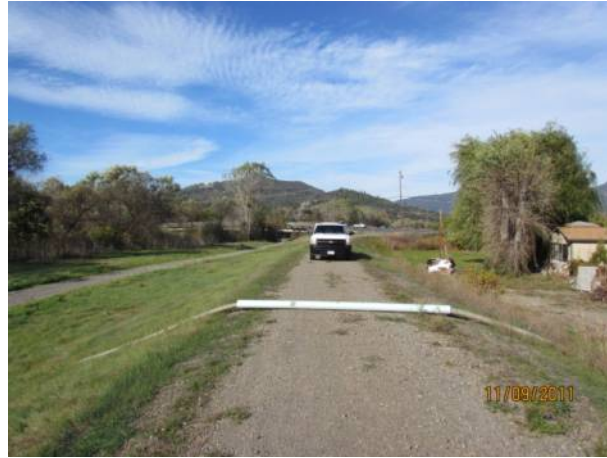
Levee Mile Report Line	1
Start Levee Mile	2.10
End Levee Mile	2.10
Location	Crown
Category	Earthen Levee
Item	Encroachments

View of the drain pipe going across the levee.

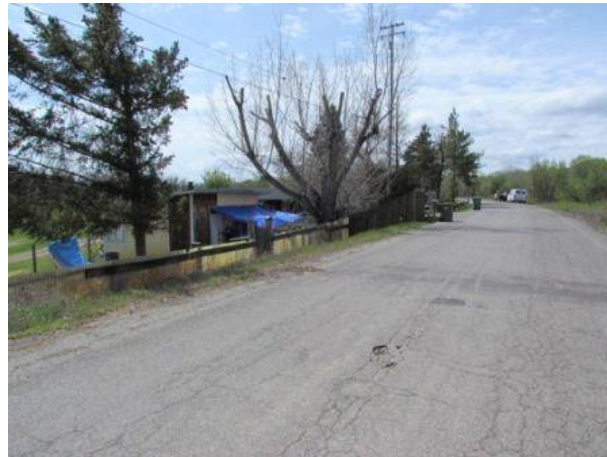
Levee Mile Report Line	4
Start Levee Mile	2.58
End Levee Mile	2.61
Location	Land Side
Category	Earthen Levee
Item	Encroachments

View of the fences at the L/S toe.

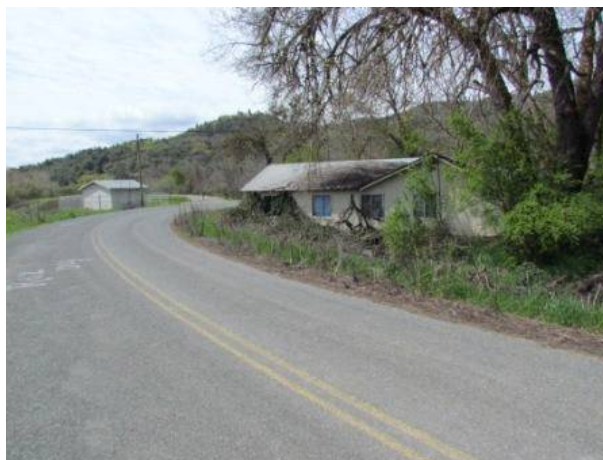
Levee Mile Report Line	1
Start Levee Mile	0.20
End Levee Mile	0.20
Location	Land Side
Category	Earthen Levee
Item	Encroachments

View of the vegetation and building next to the landside toe of levee.

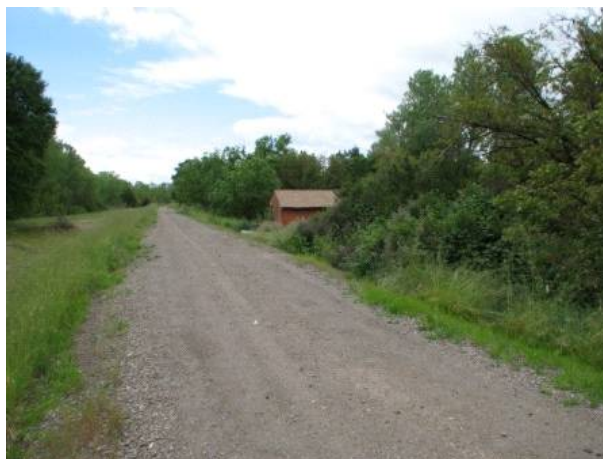
Levee Mile Report Line	3
Start Levee Mile	1.05
End Levee Mile	1.05
Location	Land Side
Category	Earthen Levee
Item	Encroachments

View of building & vegetation along the levee toe.

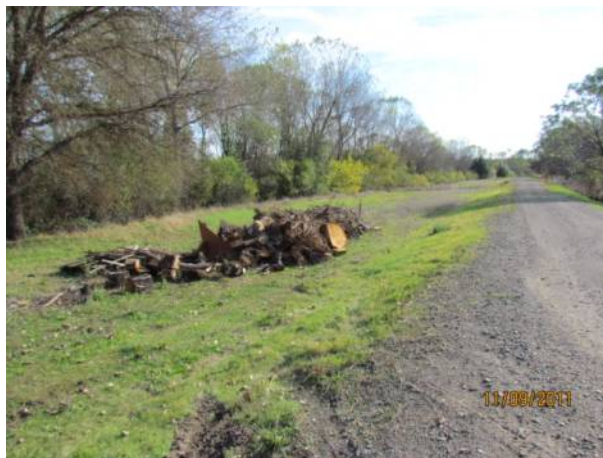
Levee Mile Report Line	4
Start Levee Mile	1.06
End Levee Mile	1.06
Location	Land Side
Category	Earthen Levee
Item	Encroachments

View of the tree prunings on the W/S toe.

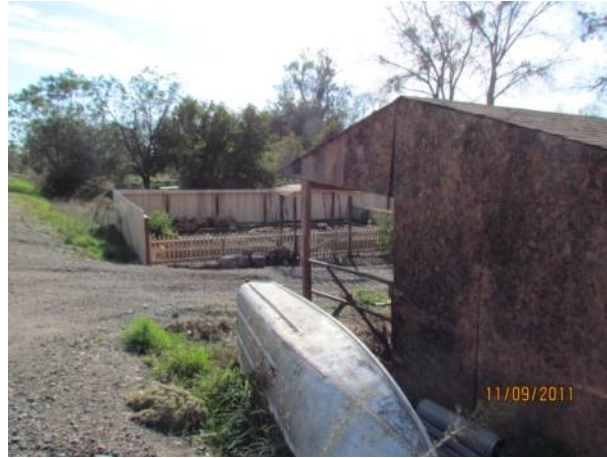
Levee Mile Report Line	5
Start Levee Mile	1.06
End Levee Mile	1.06
Location	Land Side
Category	Earthen Levee
Item	Encroachments

View of the building & fence along the L/S toe.

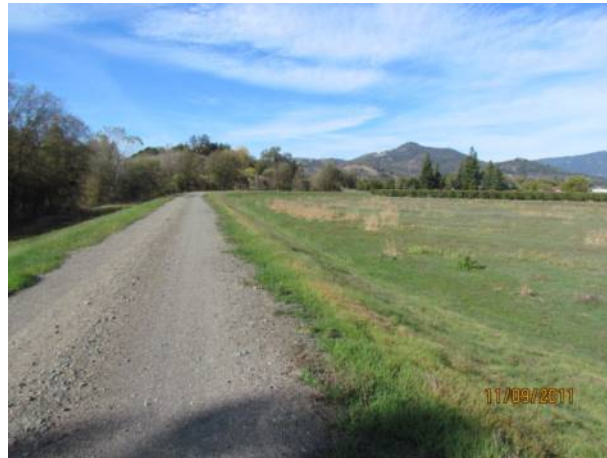
Levee Mile Report Line	1
Start Levee Mile	0.53
End Levee Mile	0.53
Location	Land Side
Category	Earthen Levee
Item	Vegetation

View of the clean levee.

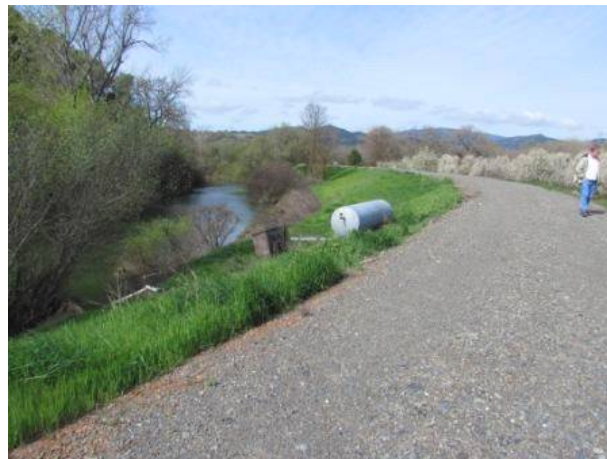
Levee Mile Report Line	2
Start Levee Mile	0.97
End Levee Mile	0.97
Location	Water Side
Category	Earthen Levee
Item	Encroachments

View of a tank that needs to be removed from the W/S slope.

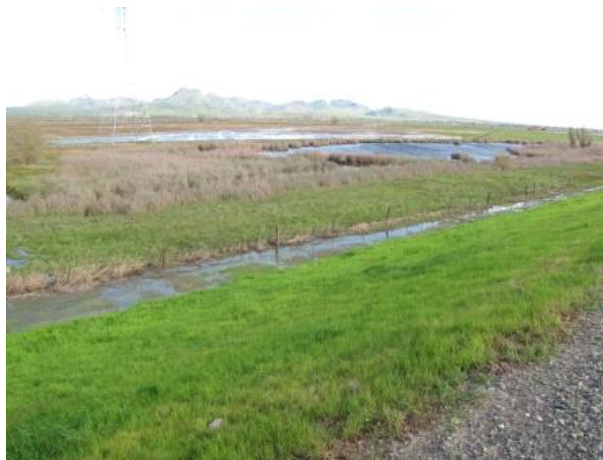
Levee Mile Report Line	2
Start Levee Mile	0.90
End Levee Mile	0.90
Location	Land Side
Category	Earthen Levee
Item	Encroachments

View of the garbage and wood on the landside slope of the levee.

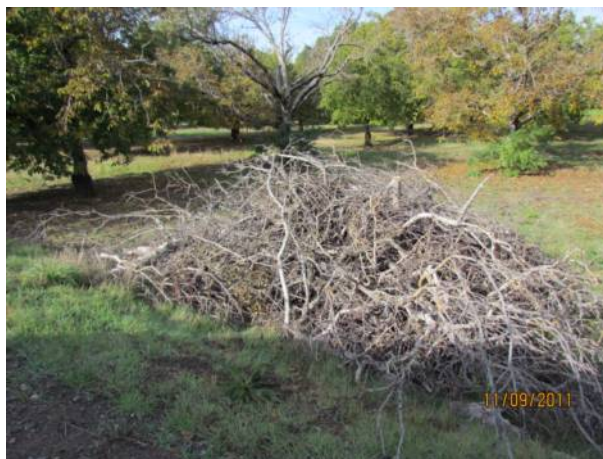
Levee Mile Report Line	3
Start Levee Mile	0.90
End Levee Mile	0.90
Location	Land Side
Category	Earthen Levee
Item	Encroachments

View of the walnut tree pruning along the L/S toe.

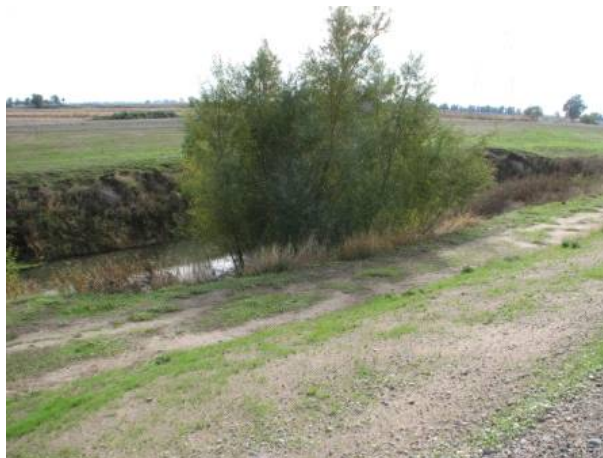
Levee Mile Report Line	4
Start Levee Mile	1.05
End Levee Mile	1.18
Location	Land Side
Category	Earthen Levee
Item	Trim / Thin Trees

View of trees that need to be removed.

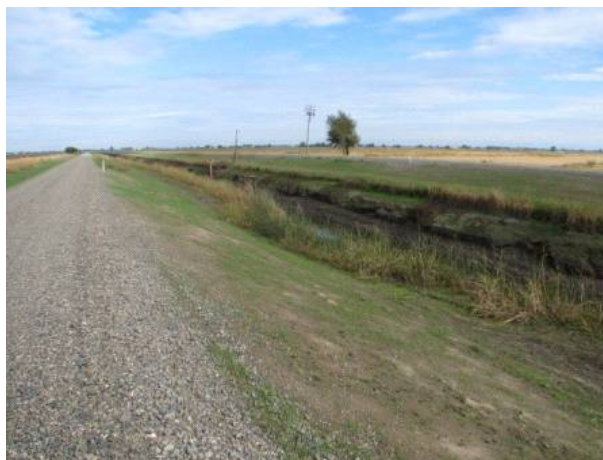
Levee Mile Report Line	1
Start Levee Mile	0.30
End Levee Mile	0.30
Location	Land Side
Category	Earthen Levee
Item	Vegetation

View of the elderberries along the landside toe of the levee.

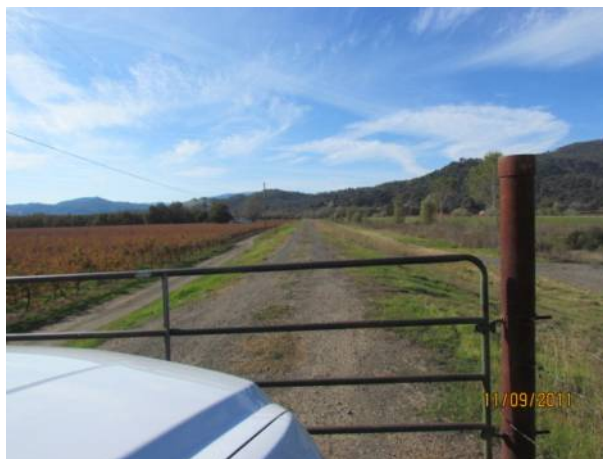
Levee Mile Report Line	2
Start Levee Mile	0.55
End Levee Mile	0.55
Location	Land Side
Category	Earthen Levee
Item	Vegetation

View of the clean levee.
